Name of Dam: Mays Dam

Location: Amherst County, State of Virginia

Inventory Number: VA 00909

PHASE I INSPECTION REPORT
NATIONAL DAM SAFETY PROGRAM

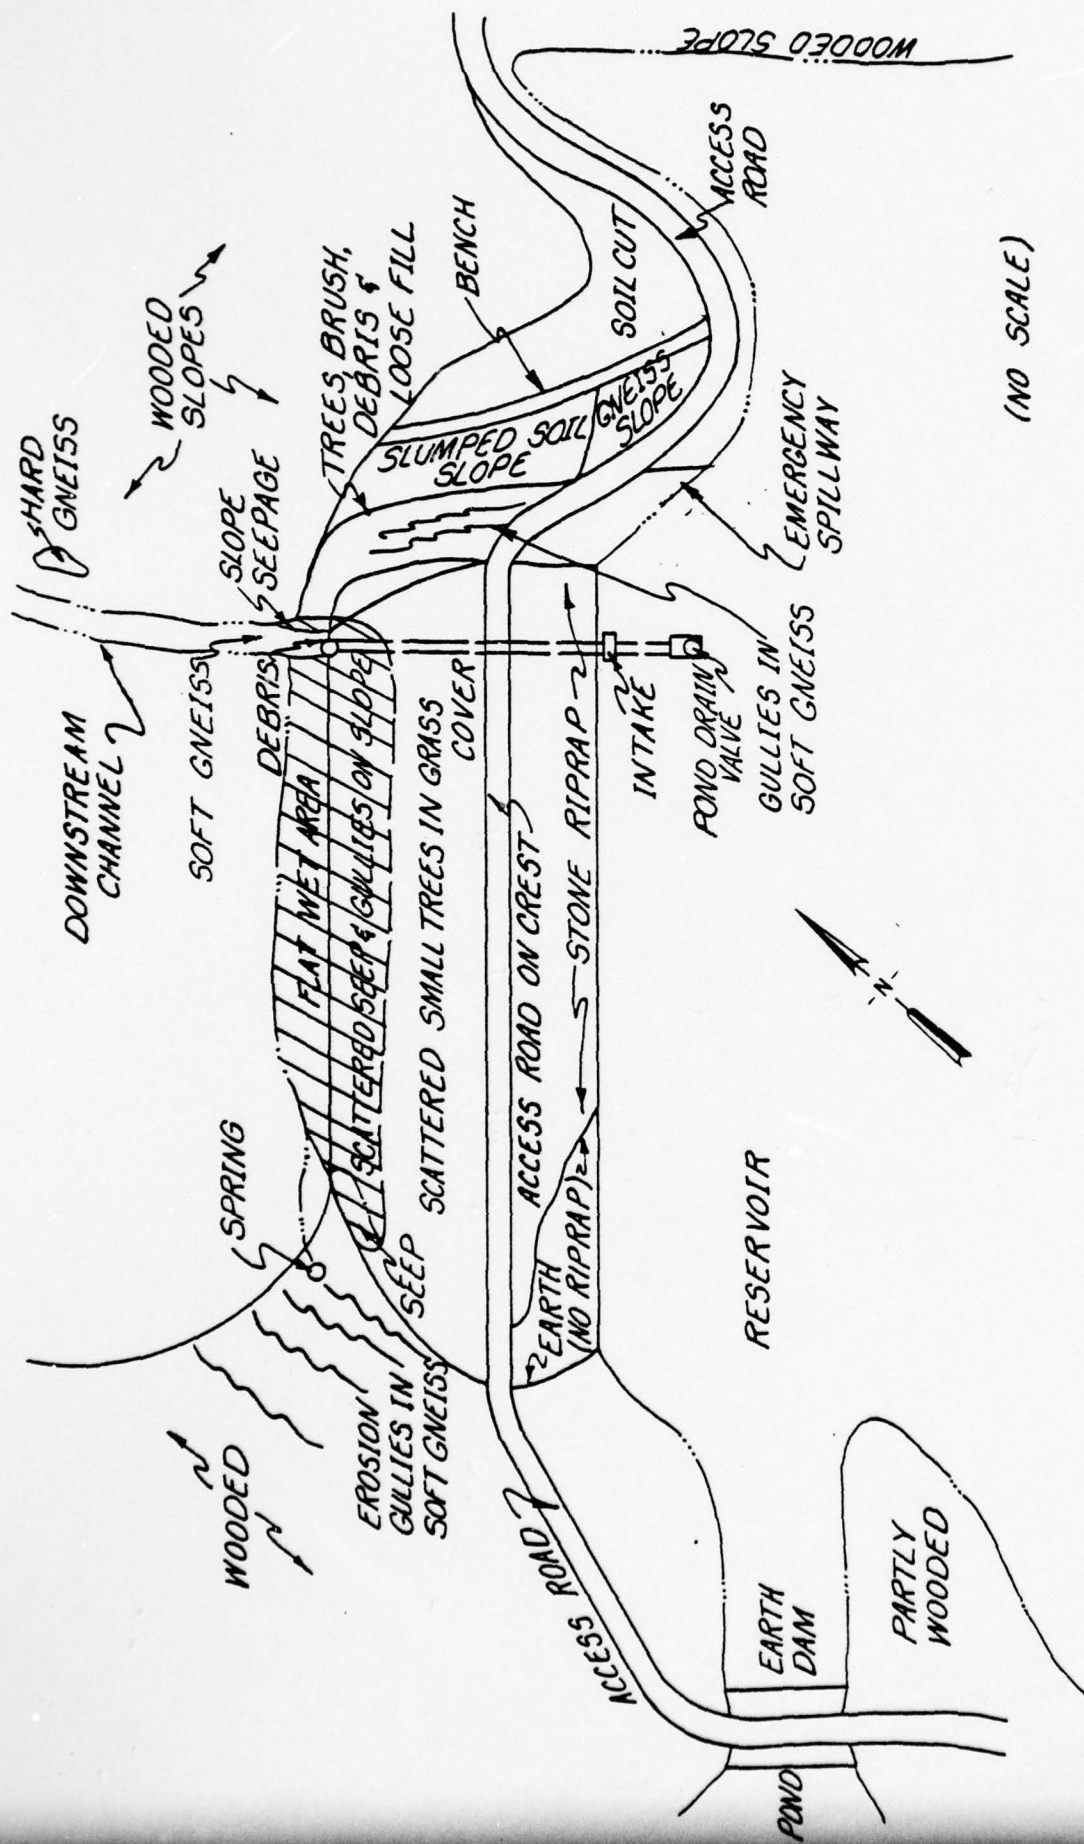
MAYS DAM
Michael Baker, Jr., Inc.
July 1979
PLATE I

- 3.1.2 Dam: The embankment was generally found to be in satisfactory condition, with no surface cracks, slumps, or other indications of instability either on the embankment or at the toe. Numerous small erosion gullies have formed in the lower portion of the downstream slope where scattered, nonmeasurable seepage is prevalent (see Plate 1 and Photos 3 and 4). An upper limit of clear seepage on the downstream embankment was very noticeable at approximate elevation 752 feet M.S.L., 8 feet below normal pool. There is good grass cover with some small trees on the downstream slope (see Overall View of Dam). Dumped riprap covers most of the upstream slope except for a section on the left side (see Photo 1 and Plate 1). A road crosses the crest of the dam and the spillway.

- There is a spring with a flow of 1 g.p.m. from the hillside near the left abutment of the dam. The spring does not appear to affect the embankment (see Plate 1). There are some bare and eroded areas on the hillside at the left abutment (see Photo 2).

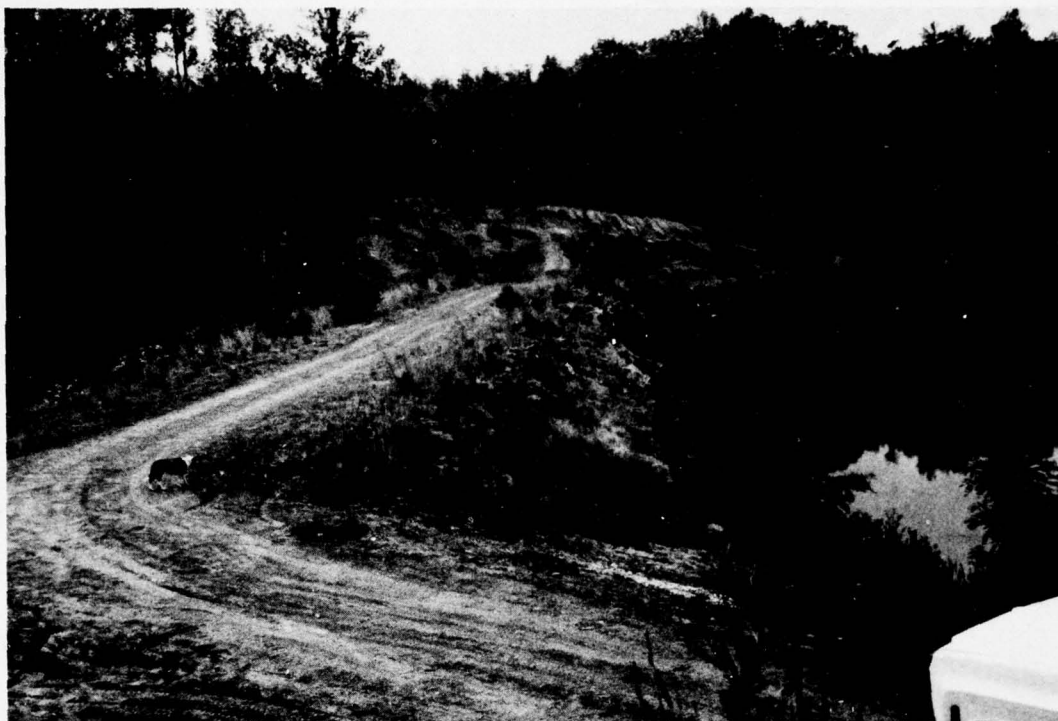
PHOTO 1. Upstream Face of Dam Showing Dumped Rock and Cut Slope of Emergency Spillway at Right Abutment

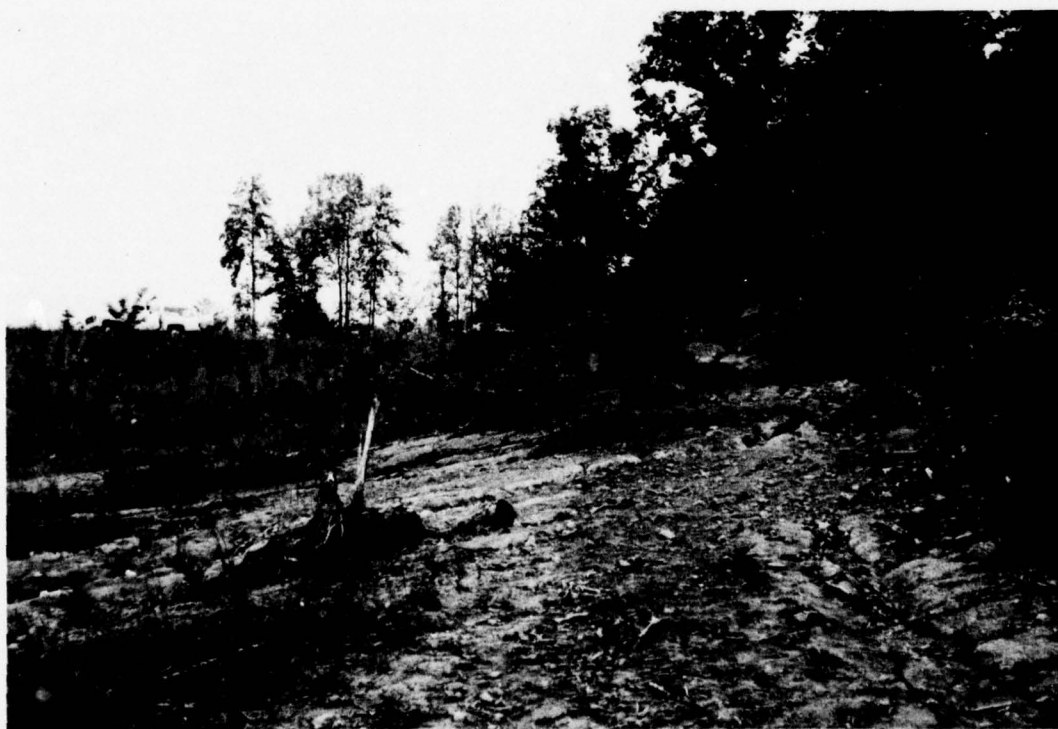
PHOTO 2. Eroded Area on Left Abutment

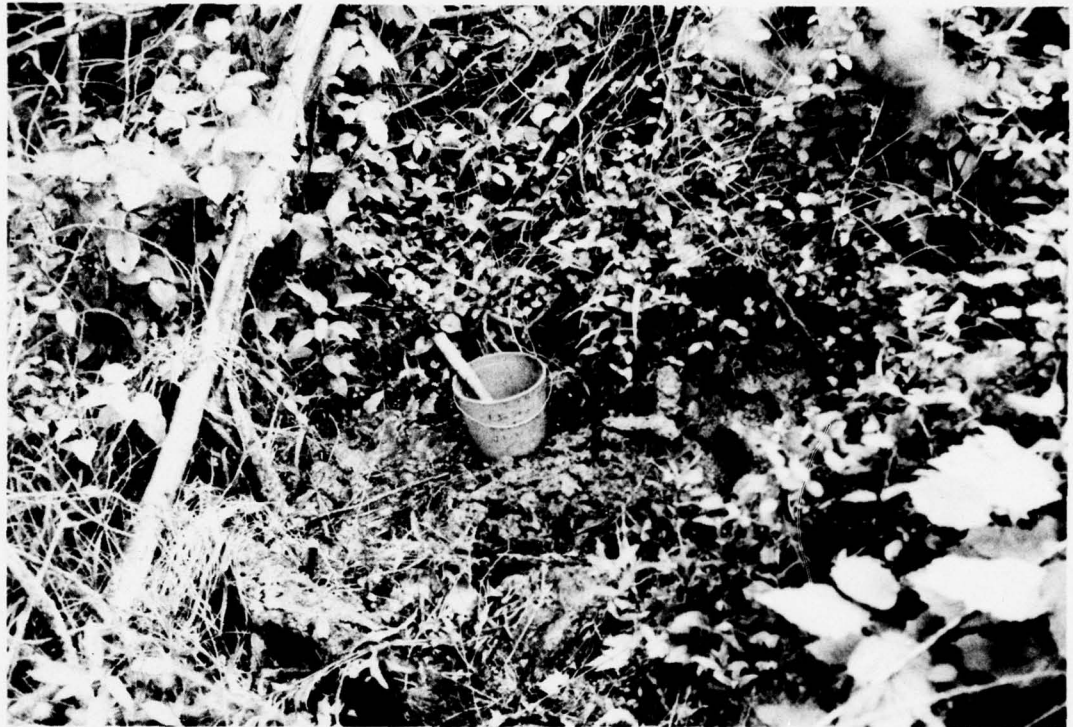
PHOTO 3. Close-up View of Seepage Area Located Near Right Side of Outlet Pipe

Numerous seeps in small to moderately large wet areas in the lower 15 ft. of the downstream slope were observed. The flow was too small to measure except for an estimated 0.3 g.p.m. in the earth slope gutter at the lower left abutment. There is a spring (1 g.p.m.) in the nearby hillside. The seepage at the right abutment was too small to measure. There is a wet area extending along the toe of the dam with a variable width (30 ft. maximum). The water drains into the adjacent stream channel.

occur if adequate compaction was not attained during construction of the shell. Therefore, it is recommended that the seepage areas on the downstream slope be visually inspected during all periods of high reservoir levels to determine (1) any increases in turbidity and/or (2) increases in the rate of seepage. In the interim, a qualified professional engineer should be engaged to investigate the stability of the embankment. These analyses should be made based on full loading conditions with a high phreatic line or on conditions determined from a subsurface investigation.

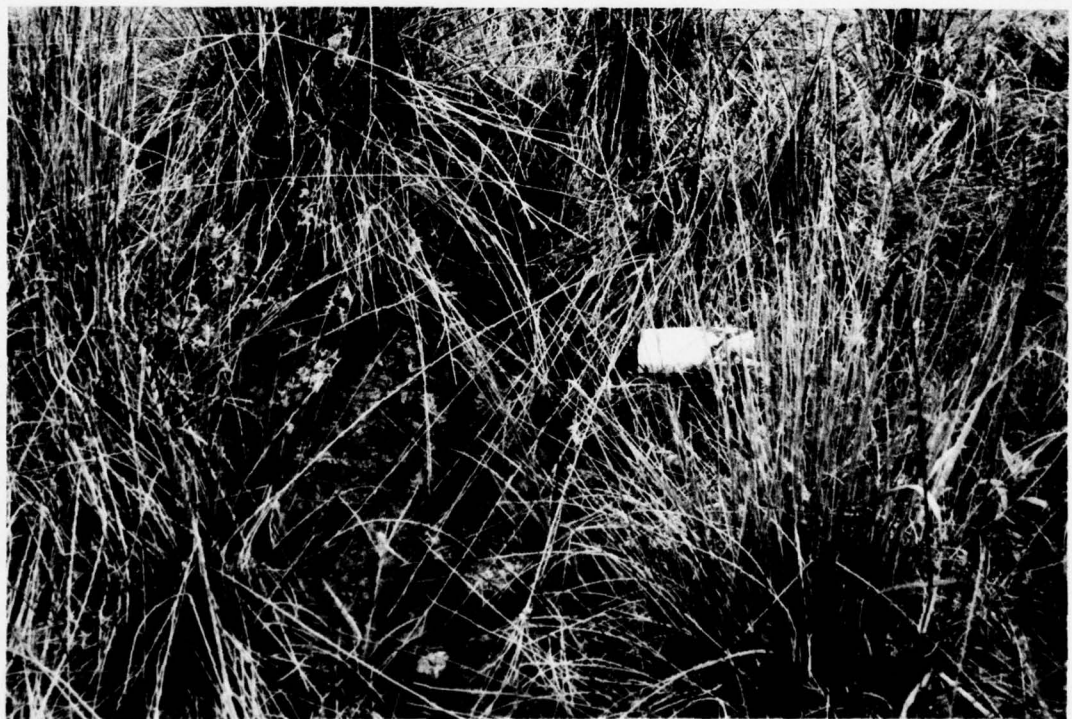
**PHOTO 4. Close-up View of Seepage Area Located to the Left of the Outlet Pipe
at Downstream Toe of Dam**

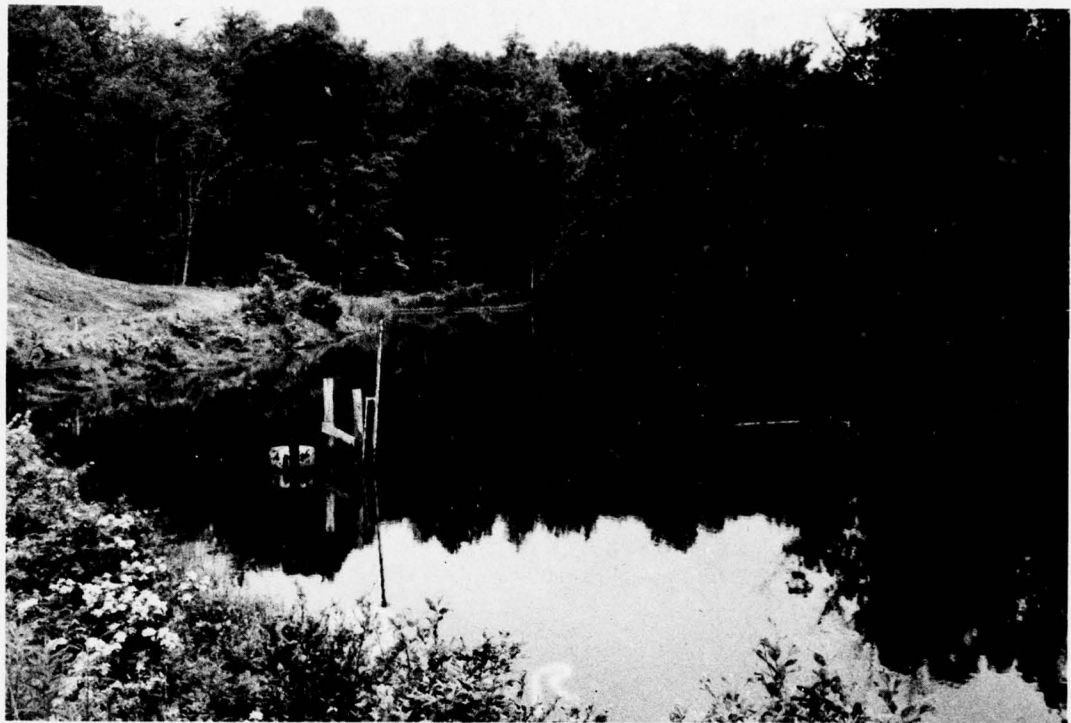
- 3.1.3 Appurtenant Structures: The principal spillway consists of an 8 inch vertical section of pipe (see Photo 5) which is connected to a 20 inch diameter horizontal steel pipe extending through the embankment and outletting near the right abutment (see Photo 6). The intake pipe appeared to be structurally sound with

steel angles supporting both it and the reservoir drain valve and stem. The principal spillway was functioning properly. The emergency spillway has a poorly defined channel to direct flow away from the dam. The discharge slope for the emergency spillway into the stilling basin is covered with vegetation. Loose earthfill has been left in the discharge slope causing obstructions to form. Eroded gullies have developed in the soil and soft bedrock of the emergency spillway (see Photo 8) and a major portion of the lower cut slope on the right side is wet and slightly slumped.

PHOTO 5. Intake Structure (Left) and Reservoir Drain Valve (Right) of Principal Spillway

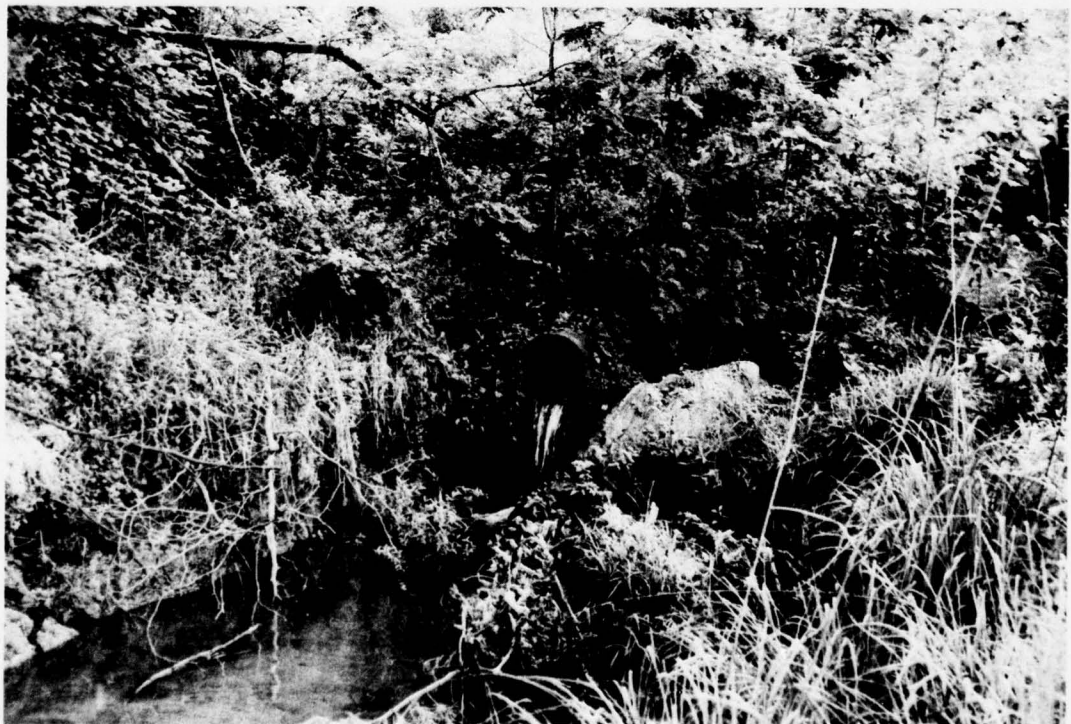
3.1.5 Downstream Channels: The stilling basin for the outlet pipe is not lined with riprap. There is weathered bedrock in the stream bottom and a loose tree stump with debris in the basin (see Photo 6). The downstream channel is in satisfactory condition (see Photo 7).

PHOTO 6. Outlet Pipe and Debris in Stilling Basin

- 6) Remove tree stumps and debris from stilling basin.
- 7) Regrade emergency spillway to remove erosion gullies and provide a defined channel away from the dam. The regraded channel should be fertilized and seeded.
- 8) Remove loose fill, debris, and excessive vegetation from the discharge channel of emergency spillway.
- 9) Seed the right cut slope of the emergency spillway.
- 10) Install a staff gage to monitor reservoir levels above normal pool.
- 11) Initiate a yearly maintenance and inspection program.

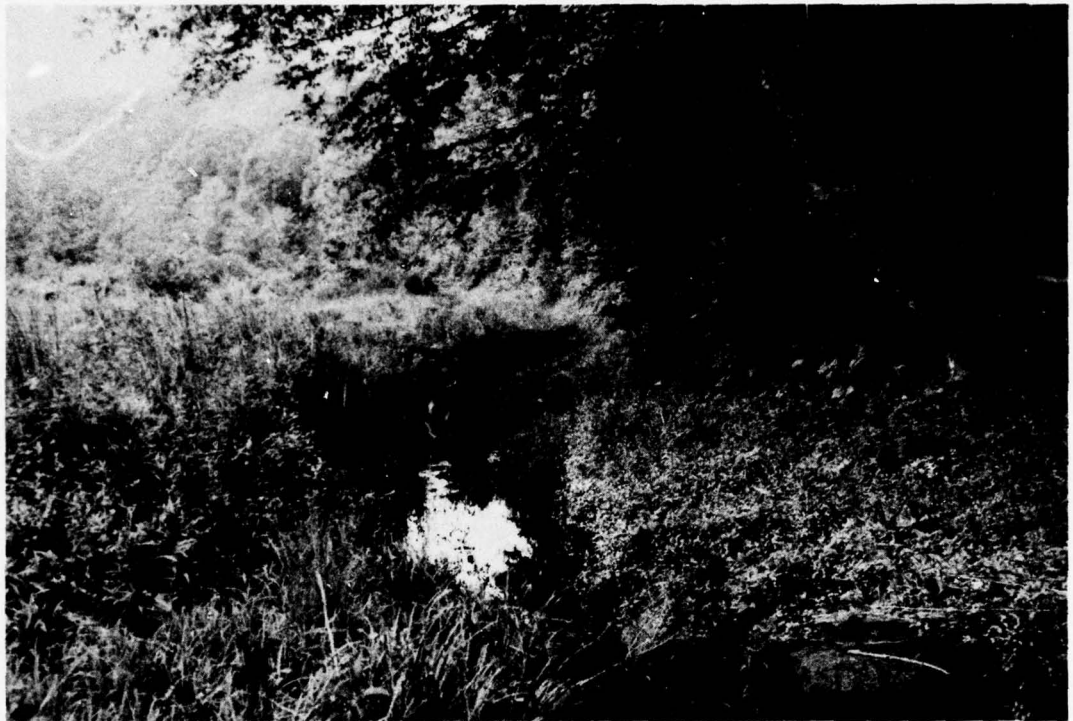
PHOTO 7. Downstream Channel

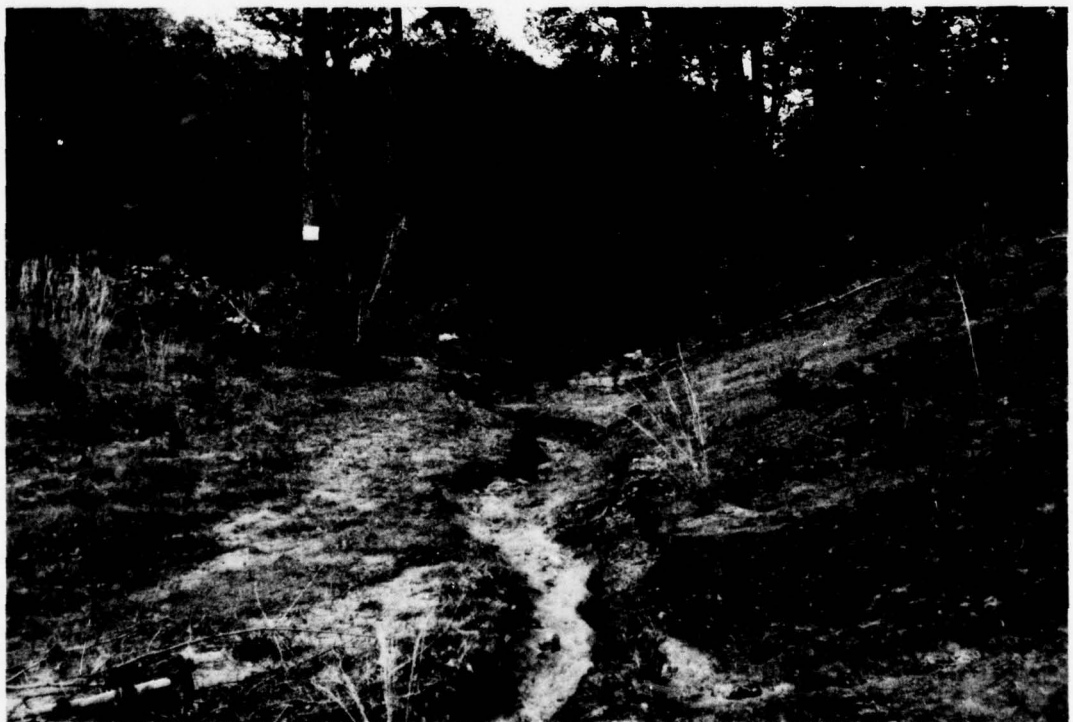
PHOTO 8. Erosion in Discharge Channel of Emergency Spillway

In the emergency spillway, the wet area in the right cut slope should be graded and seeded to prevent erosion. The debris, excessive live vegetation, and loose soil fill at the discharge end of the spillway on the slope above the stilling basin should be removed to prevent blockage.
